2008 Annual Progress Report

Date: January 2009

Project Site: Chandramauleshwar Temple, Aneundi, Hampi World Heritage Site, Karnataka, INDIA

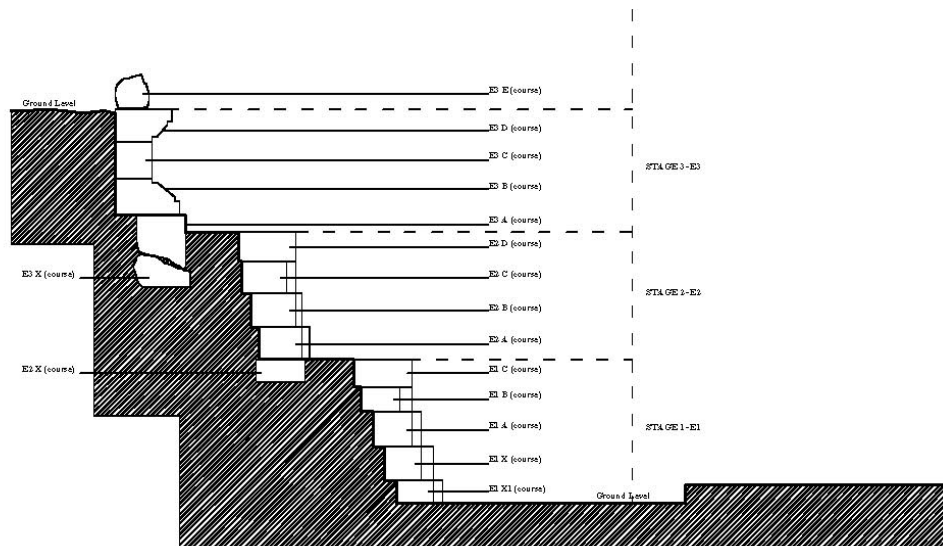
Below: Sectional drawing showing the constructional details of the Upper Embankment Wall

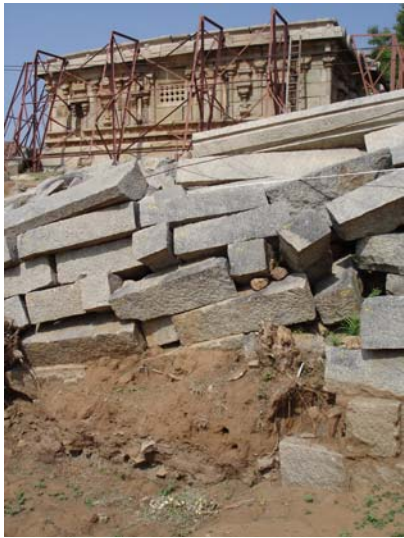
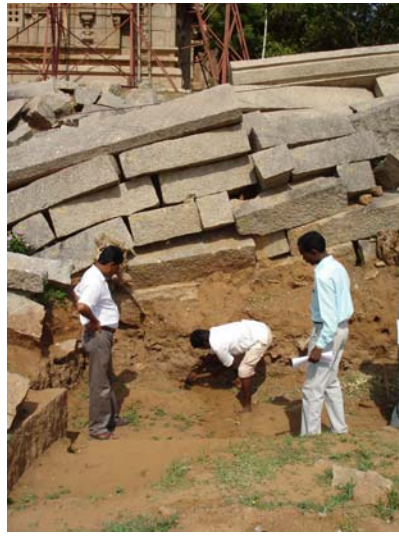
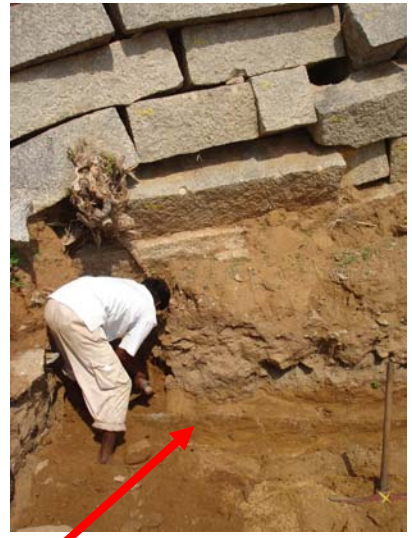
2. Investigations around Upper Embankment Wall along East Face of Temple

- Current numbering shows 4 courses of type E 1 missing in this section
- Is this indicative of a 'step down' in embankment wall level at this section? Or steps leading to the temple platform? Is it a turning or merely indicative of 'scavenging' for construction works?
- Review of explorations around the east side showing 'base course' stone but mud and rubble above that. Indicative of debris build up or construction detail against rise of steps from East platform?

'base course' stone but mud and rubble above that

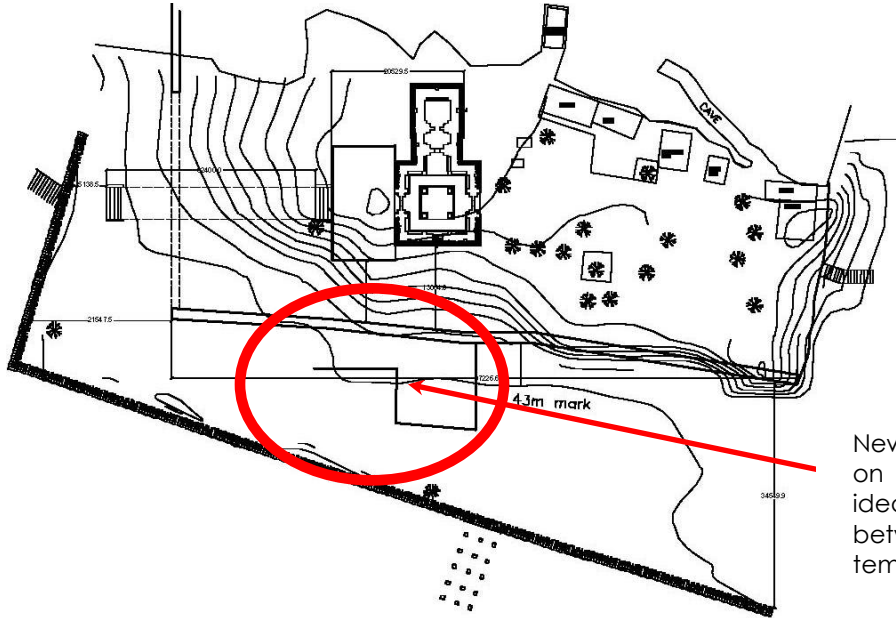
New Eastern platform discovered on site leading us to explore the idea of a pedestrian linkage between the stone bridge and the temple.

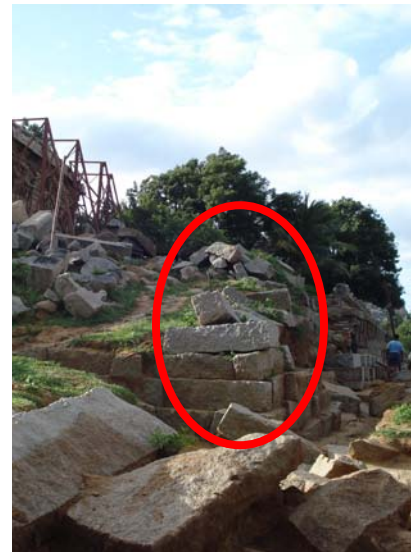
A new bend in the upper stone embankment is now visible that was earlier not seen. This leads to new light on the original construction of the upper embankment wall.

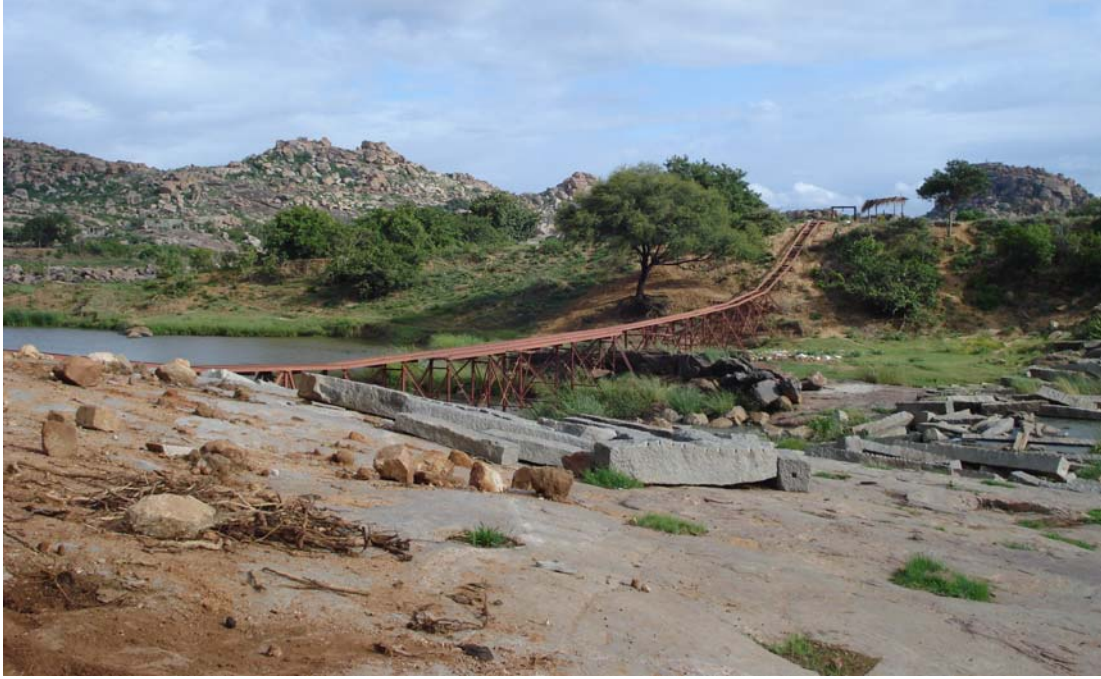
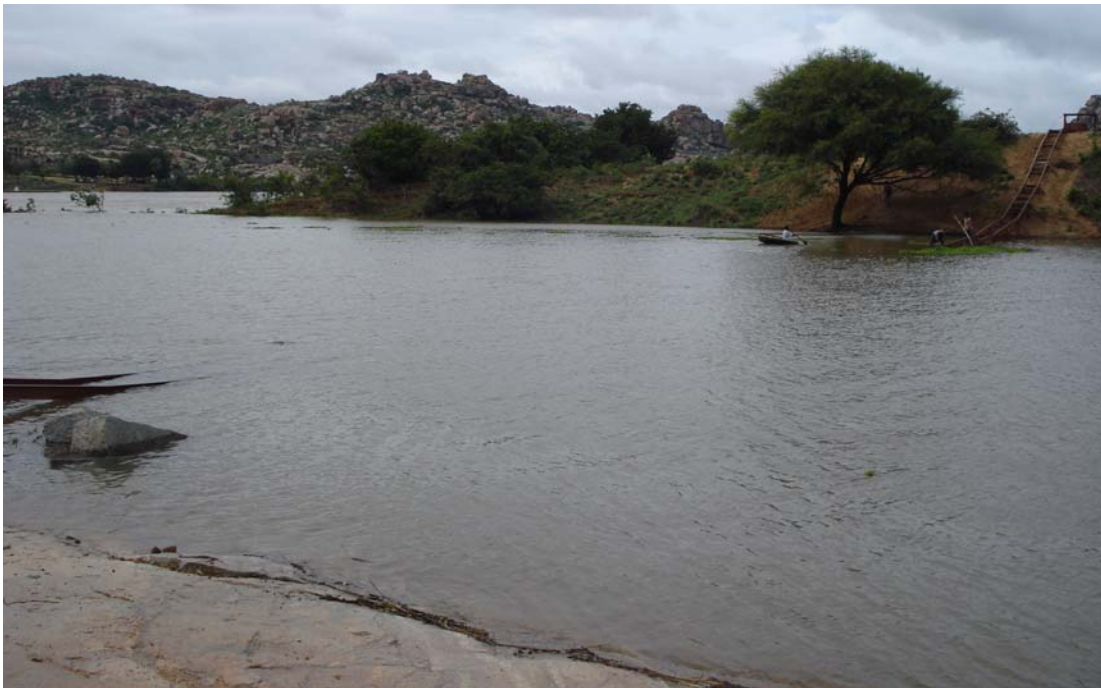
The Project Director took the picture above on 12th August after the Site Inspection. On the next morning, the entire site (picture below) was flooded as the monsoon water was released from the Tungabhadra Dam on account of heavy rains and the entire river was in spate. The entire trolley track was submerged in the river for the next 2 months making the site completely inaccessible.

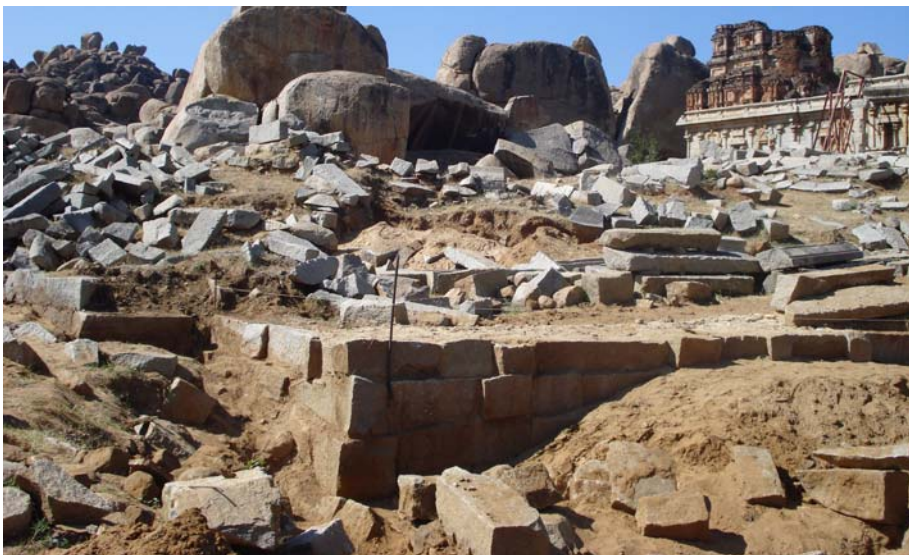
The site excavations have exposed the extant plinth level of the South East corner of the upper embankment clearly showing E1 course of the upper embankment wall extending till the SE corner. This clearly provides evidence and validates the earlier hypothesis of the site team about the turn of the upper embankment. Also exposed, is the offset at the South face of the upper embankment wall indicated steps. These are in line with the logical sequence of progression of approach to the temple along the South North axis of the temple from the lower embankment steps to the upper embankment and then with steps leading to the mandap and South entrance of the temple proper. This clearly provides evidence and validates the earlier hypothesis of the site team about the turn of the upper embankment.

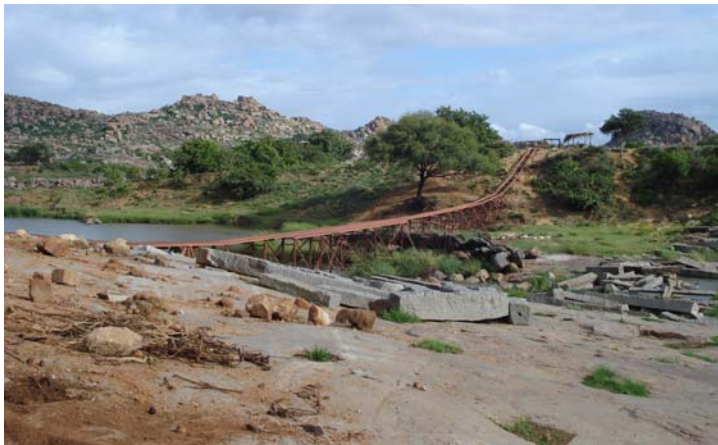
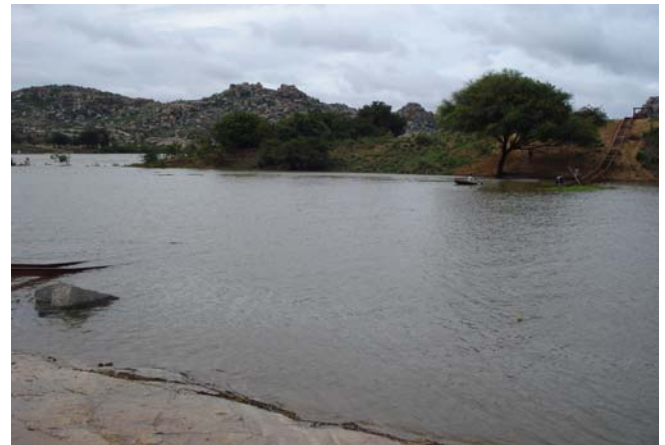
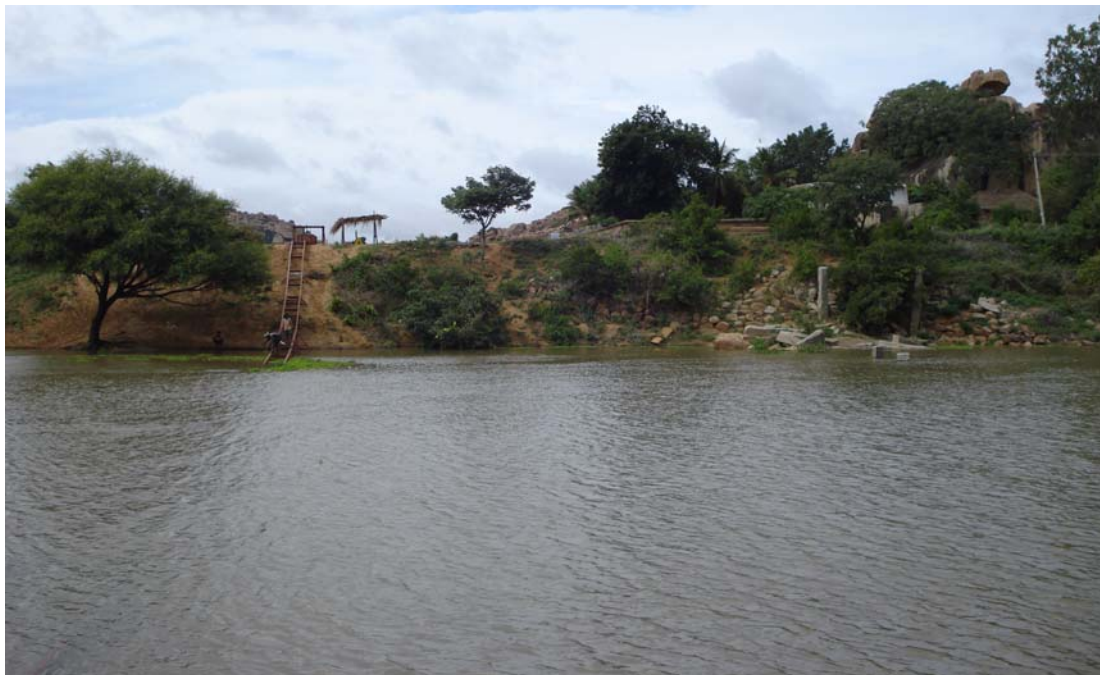
The Project Director took the picture above left on 12th August after the Site Inspection. On the next morning, the entire site (pictures above right and below) was flooded as the monsoon water was released from the Tungabhadra Dam on account of heavy rains and the entire river was in spate. The entire trolley track was submerged in the river for the next 2 months making the site completely inaccessible.
