## Site Conservation Assessment Report: Prambanan Temple Compound Indonesia

Prepared for Global Heritage Fund  
by Prof. Dr. Inajati Adrisijanti, Andi Putranto S.S.,  
and Vinsensius Ngesti W.  
Yogyakarta, Indonesia  
May 2011

**GLOBAL HERITAGE NETWORK**  
**Site Conservation Assessment Report:**  
**Prambanan Temple Compound**  
**INDONESIA**

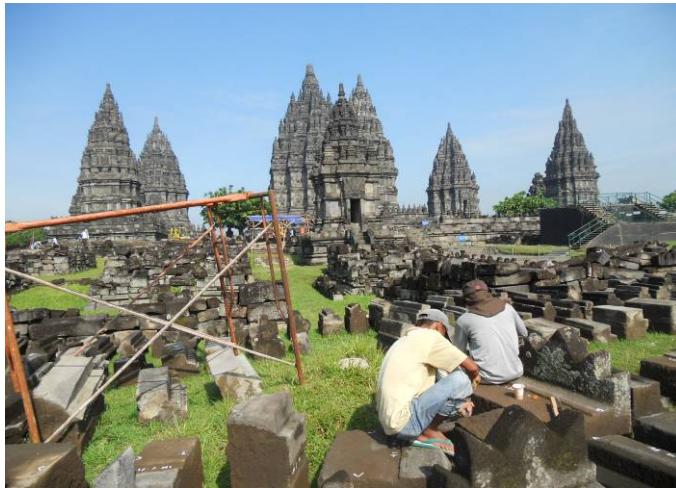
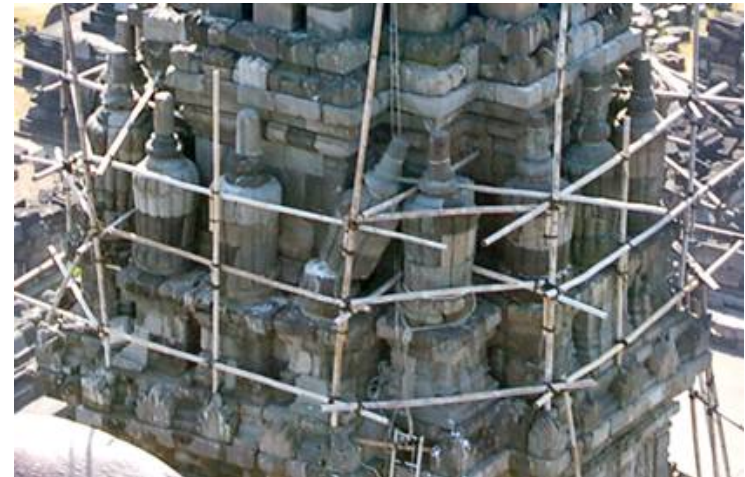
**Restoration activity in Prambanan Temple Compound**  
*(Photo courtesy of BP3 DIY)*

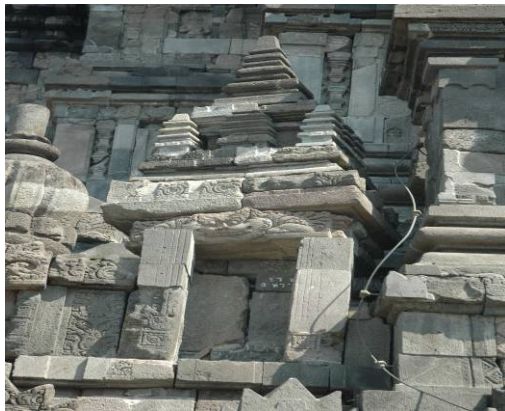
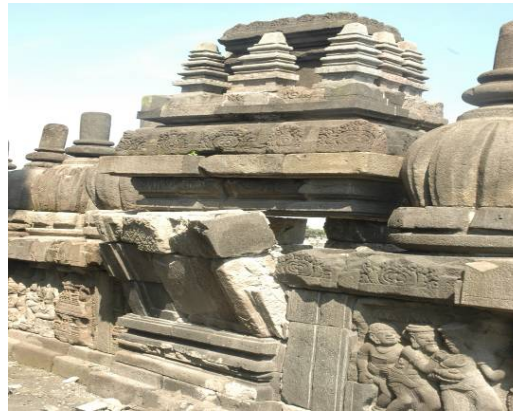
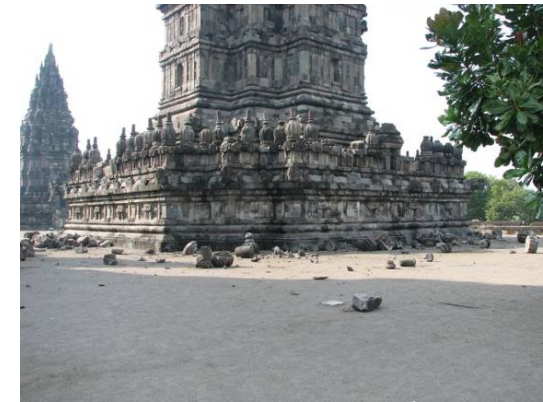
Prior to the 2006 earthquake Wisnu temple has been restored on 1982-1991. Actually its restoration begun on 1951, but then it stopped, and restarted again on 1982. After damaged by the 2006 earthquake its structure was cracked, a bit tilted, many components detached, deformed, broken, and collapsed. Many fallen stone blocks were broken into fragments. On ..... It was re-restored to its original condition.

**The damage occurred in Wishnu Temple**  
*(Photo courtesy of BP3 DIY)*

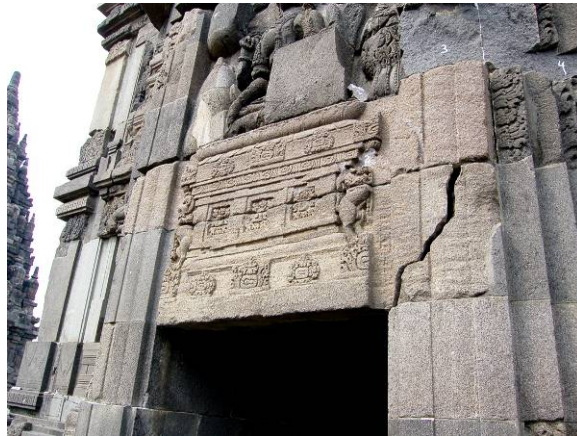
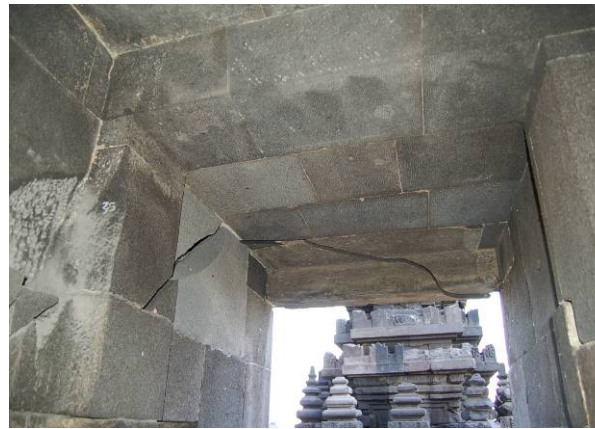
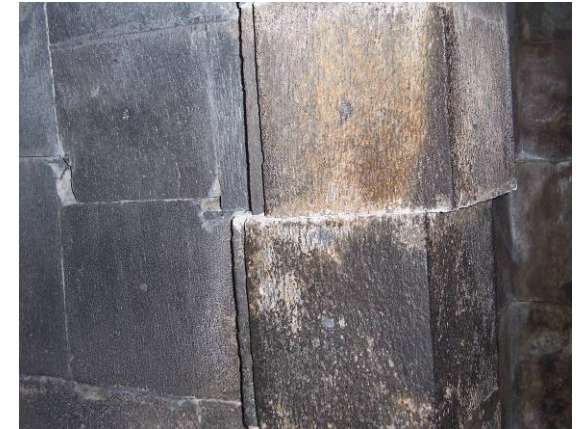
Siwa temple is the grandest building in the compound. Its primary restoration done on 1889- 1953. According to some archives and old photos the restoration was done on the body up to the roof of the temple, while the foot and the foundation were not restored because they were still stable, not deformed. The 2006 earthquake caused the structure of Siwa temple experiences damage. There are cracks 4-5 cm wide on the west sub-basement, and on the north-east and south-west parts of the foot as well. There are also outward shifts 4 cm long at the south and east stairways. On the wall of the body of the temple there are many vertical and horizontal micro cracks. Besides there were fallen, broken, and cracked stone-blocks, even some blocks experienced outward shifts caused by stress.

**The damage occurred in Siwa Temple**  
*(Photo courtesy of BP3 DIY)*

- Noted that current condition of Siwa Temple apparently need further research (e.g. horizontal cracks).
- Encourage to study more on some historic documentation of Siwa Temple restoration in the past from archives ( in the Netherlands) and to compare the inner structure of the temples with similar monument type.

- Encourage to conduct more analytical studies to gather more information on internal condition of the temple, namely through endoscopic research analysis to identify the empty space or damage on the concrete bar. Once the endoscopic research analysis is done, further analysis by opening one or two blocks of the new stones (tunneling analysis) could be conducted to study the condition/structure of the inner part of the temple and to make a more precise model. In order to conduct tunneling analysis, it is necessary to have temporary supports (use steel).

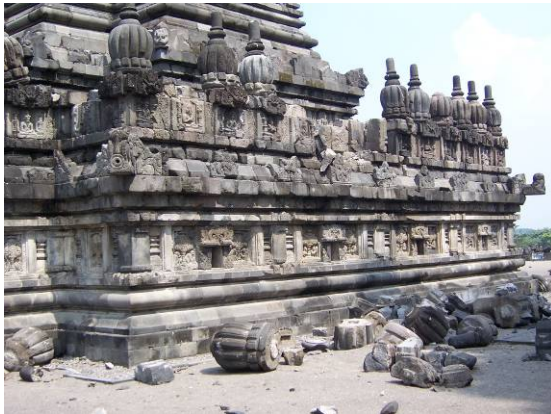
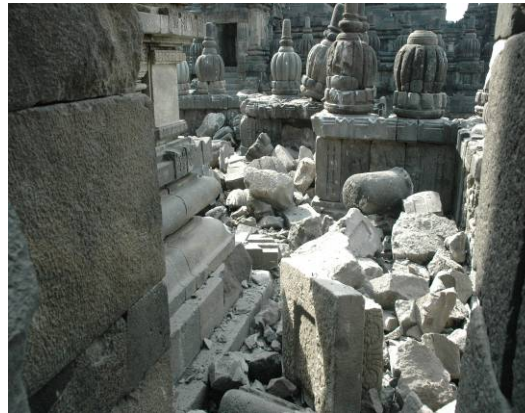
Prior to the 2006 earthquake Brahma temple was restored on 1978 – 1987. The restoration was done from the foundation up to the roof, by inserting concrete reinforcements. During the 2006 earthquake the temple experienced cracks, some stone blocks of the roof and north balustrade fell down and broken. The fallen stone blocks also damaged the body and the foot of the temple.

**The damage occurred in Brahma Temple**  
*(Photo courtesy of BP3 DIY)*

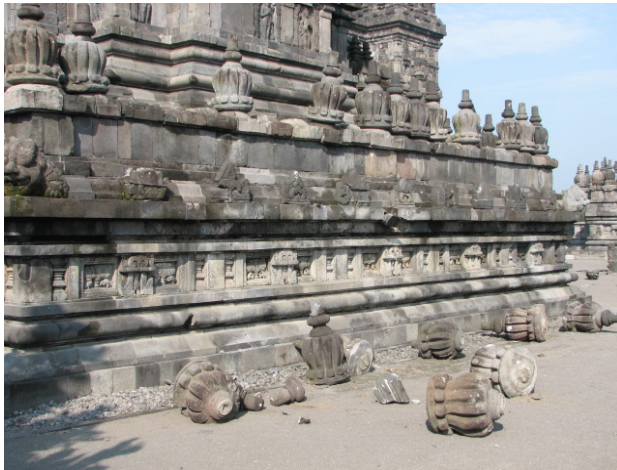
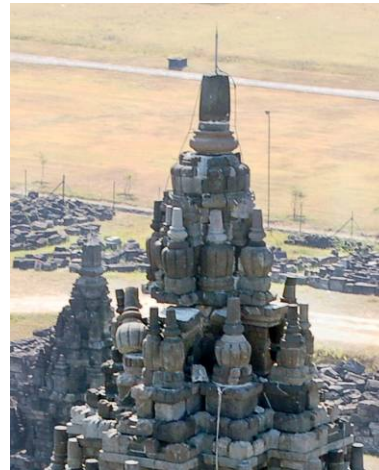
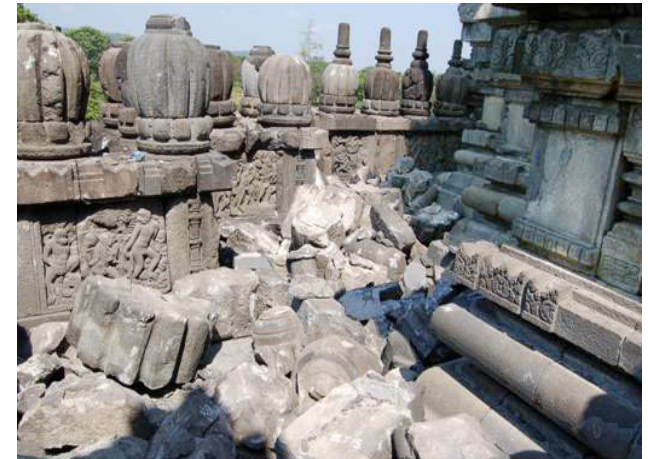
Prior to the 2006 earthquake Garuda temple was restored on 1991 – 1993 simultaneously with the other smaller temples in the first courtyard. But the earthquake damaged the temple again, especially on the roof. Some components of the roof, e.g. the *ratna*, shifted, or detached and fell down in the courtyard. The balustrade also damaged, e.g. some *ratnas* fell down also. Many stone blocks cracked or broken. Its restoration was carried out on 2007-2008

**The damage occurred in Garuda Temple**  
(Photo courtesy of BP3 DIY)

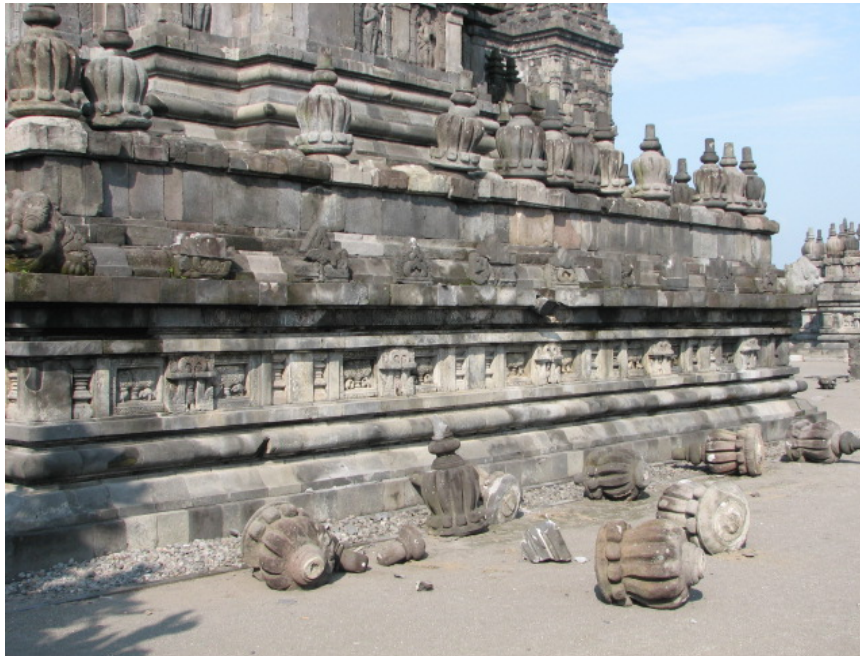
Nandi temple actually was restored on 1991-1993 together with the smaller temples in the 1<sup>st</sup> courtyard. During the 2006 earthquake Nandi temple did not experience heavy damage, except the top of the finial was broken and several *ratnas* of the balustrade were broken. Its restoration was carried out on 2007-2008.

**The damage occurred in Nandi Temple**  
(Photo courtesy of BP3 DIY)

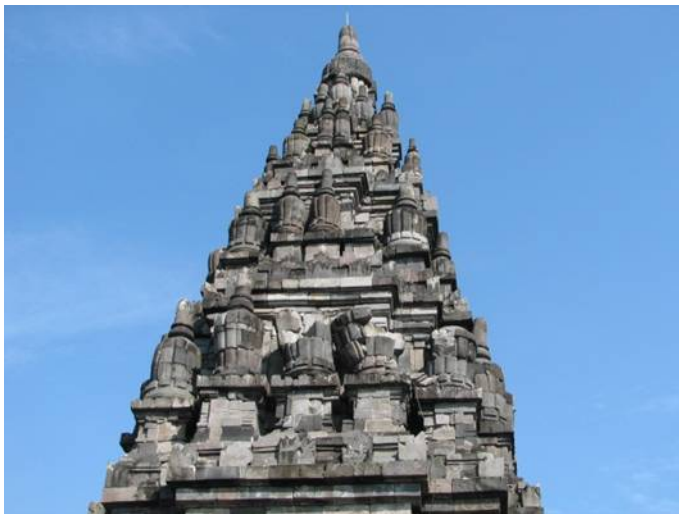
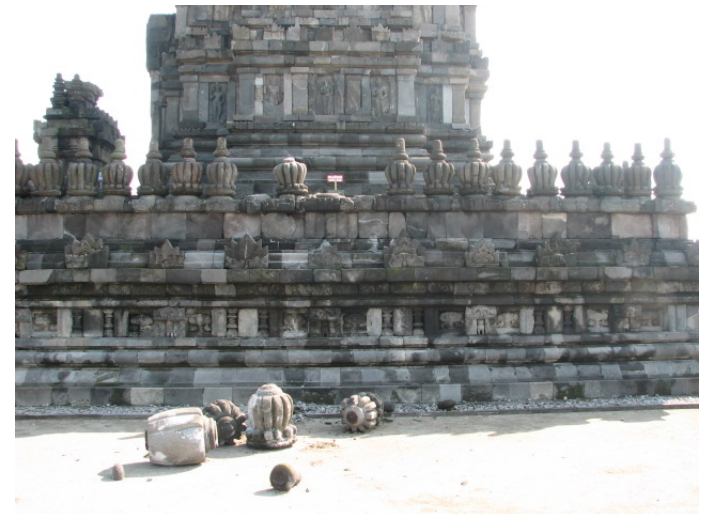
The 2006 earthquake damaged Angsa Temple similar to the other temples. Several *ratnas* of the roof and of the balustrade broken and fell down, many stone blocks were also broken and cracked. This temple was restored again on 2007-2008.

**The damage occurred in Angsa Temple**  
*(Photo courtesy of BP3 DIY)*

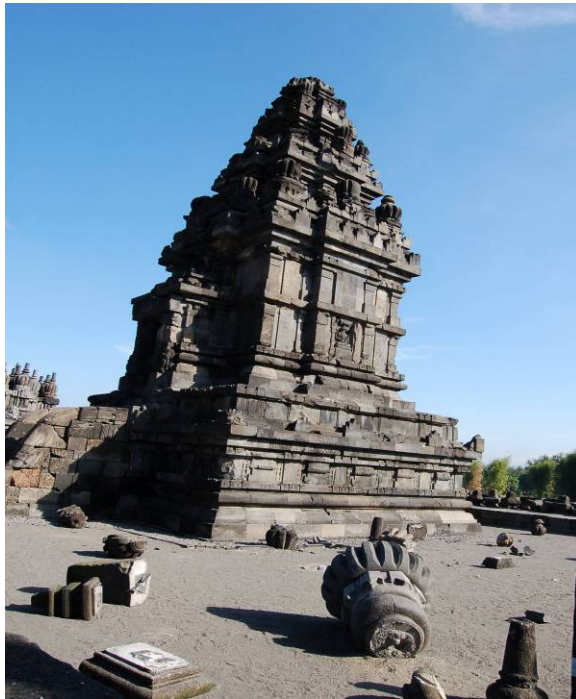
The damage on the North and South Apit Temple mainly were material damage, i.e. the stone blocks were broken and cracked. The finial of the North Apit Temple was broken and fell down, thrust in the ground. The eight Patok Temple only experienced deformation on the finials which could be restored quickly afterwards. But the enclosure wall and the gateways were crumbled down.

**The Damage**  
*(Photo courtesy of BP3 DIY)*

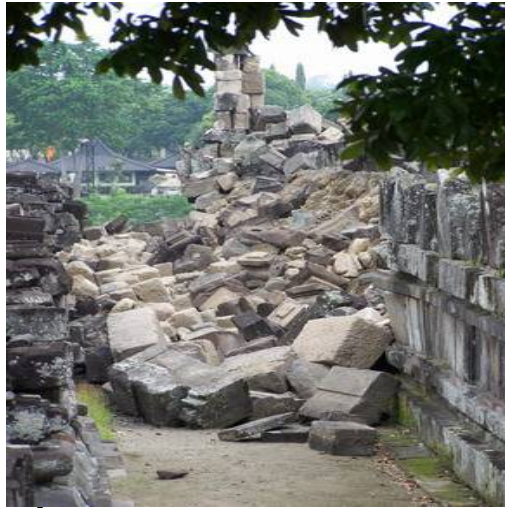
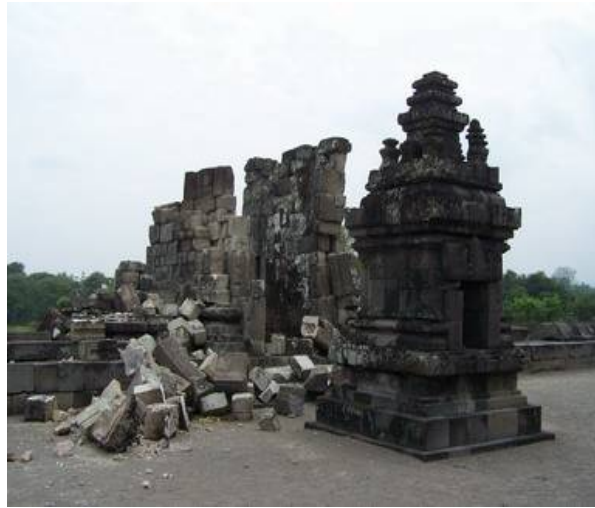
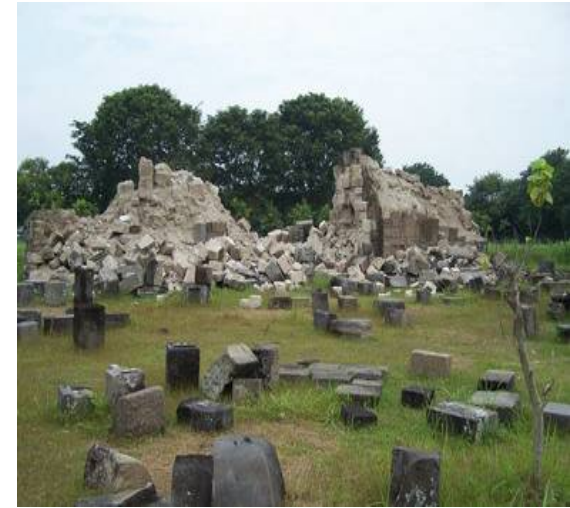
**Damage I in several area**  
***(Photo courtesy of BP3 DIY)***

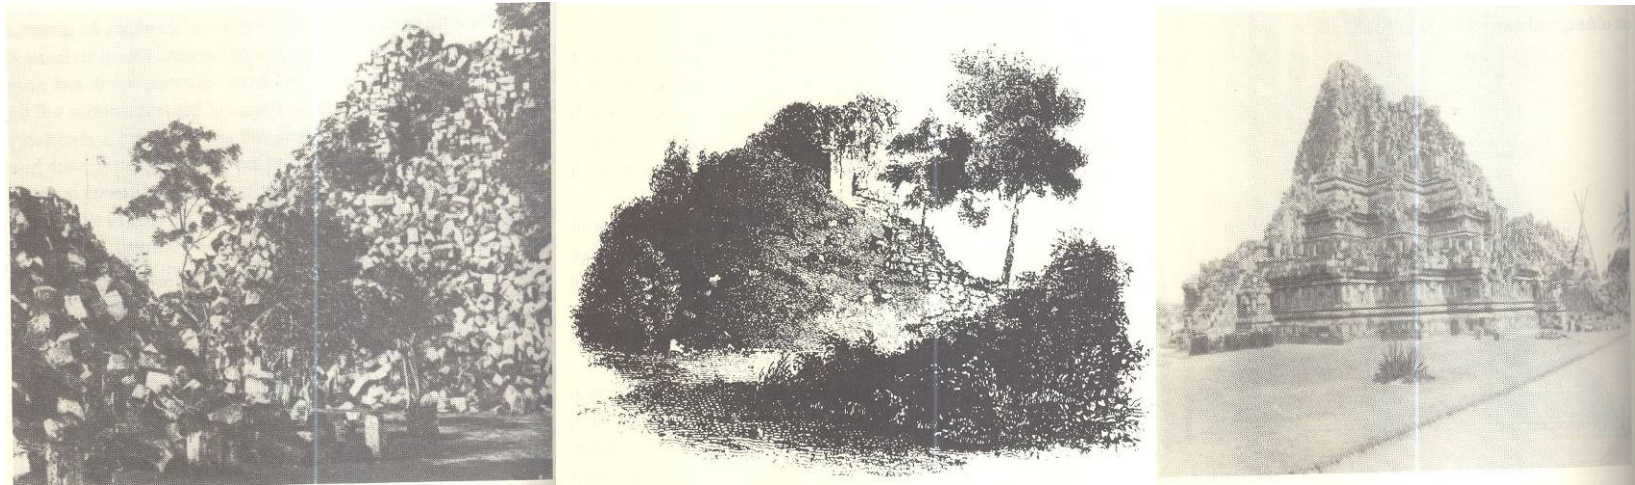
According to the archives, the reconstruction activities began on 1885 led by J.W.Ijzerman as the Head of *Oudheidkundige Vereeniging*, an NGO at that time. He ordered the workers to clean the courtyard from the scattered stone blocks without any documentations. Later, it turned out that this activity made the restoration di

sturbed, because the restorer had to seek the stone blocks not at certain place. On 1889 Groeneman explored all temples in the 1<sup>st</sup> courtyard, but he did nothing else, on the contrary he ordered to put away many stone blocks to the edge of Opak river flows at the west of the compound.

**The Prambanan Temple condition when it was rediscovered**

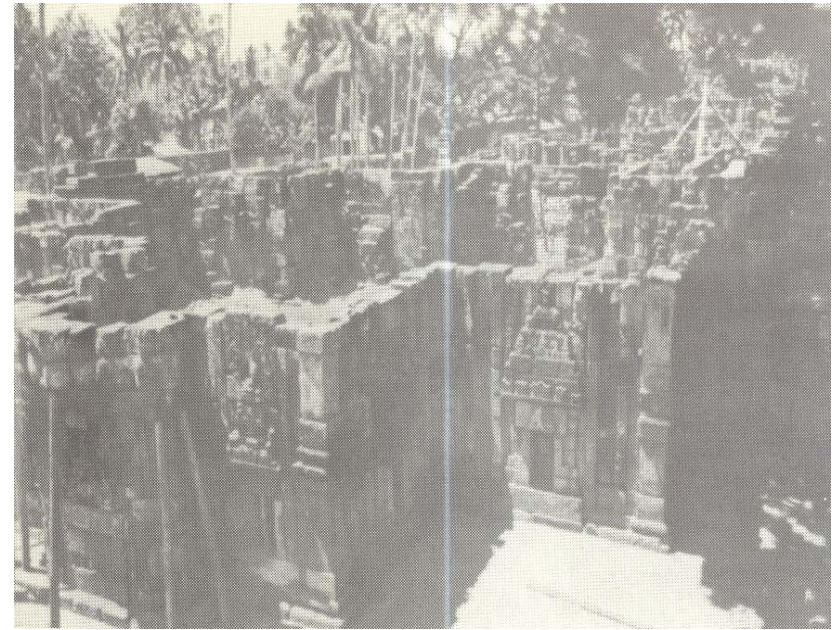
But, systematic restoration by *Oudheidkundige Dienst* just started on 1918 led by Perquin. It means that they began classifying the fallen stone blocks, dismantled the stone blocks, putting location marks on it, making trial construction, and putting new stone blocks as substitute for the missing original ones.

### **Early restoration activity**

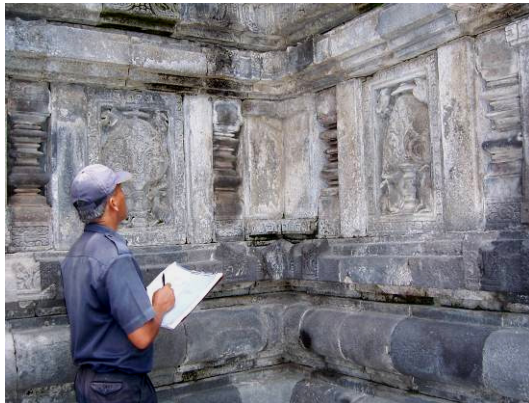
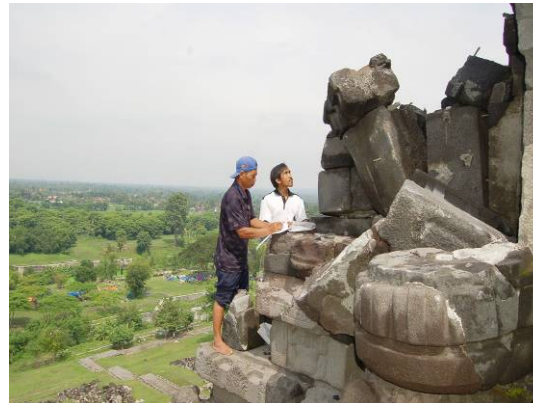
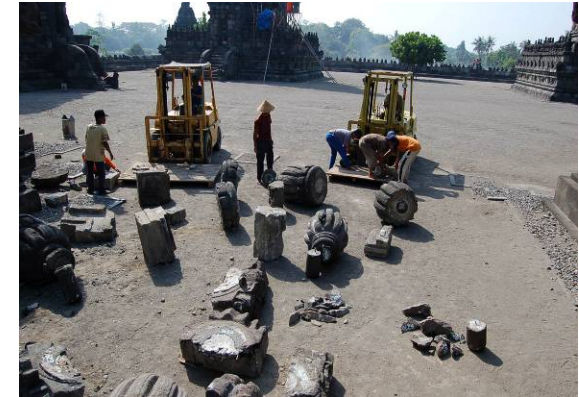
**Rehabilitation activity after 2006 earthquake**  
(*Photo courtesy of BP3 DIY*)

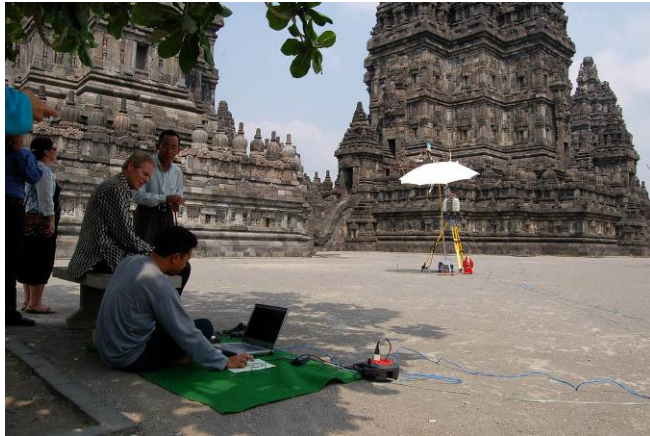
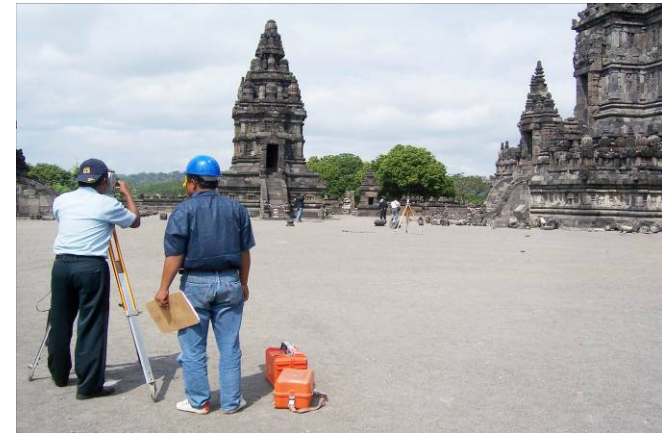
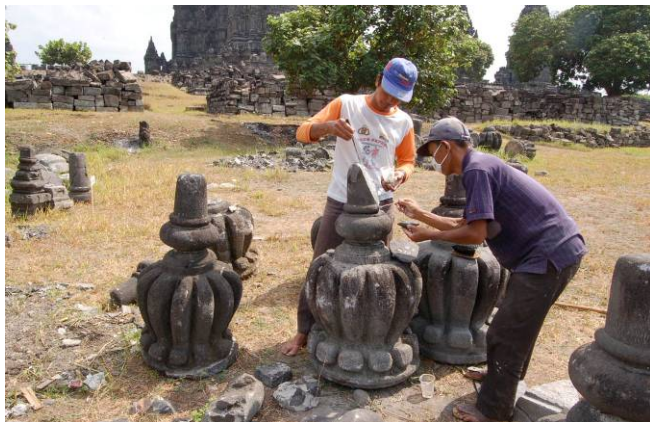
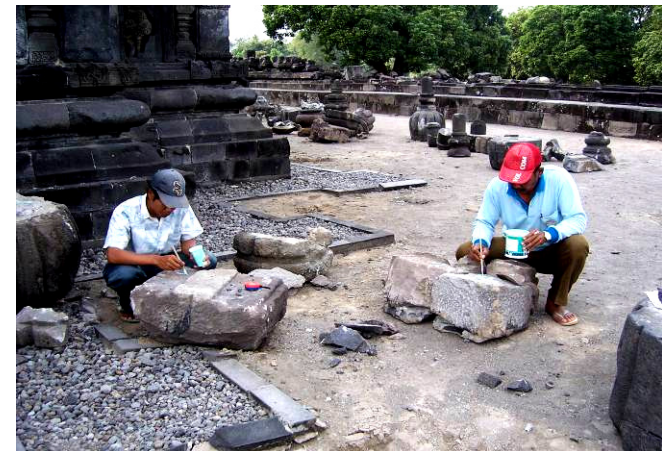
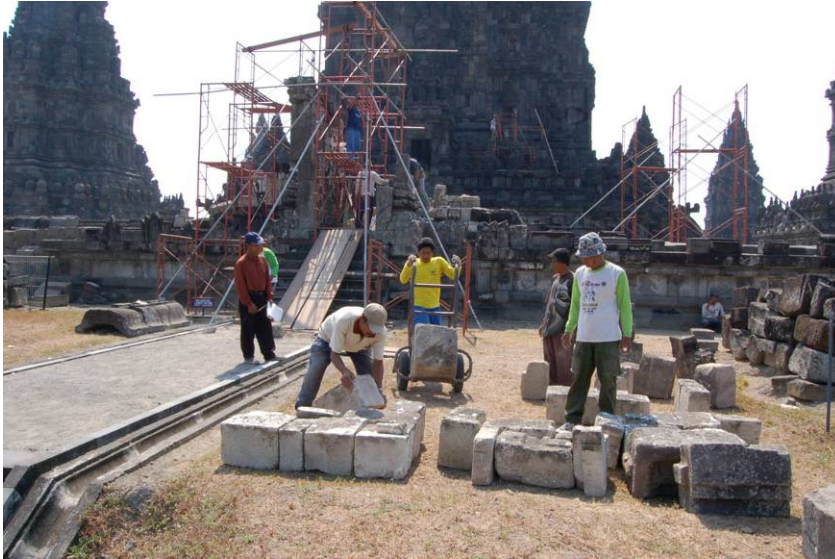
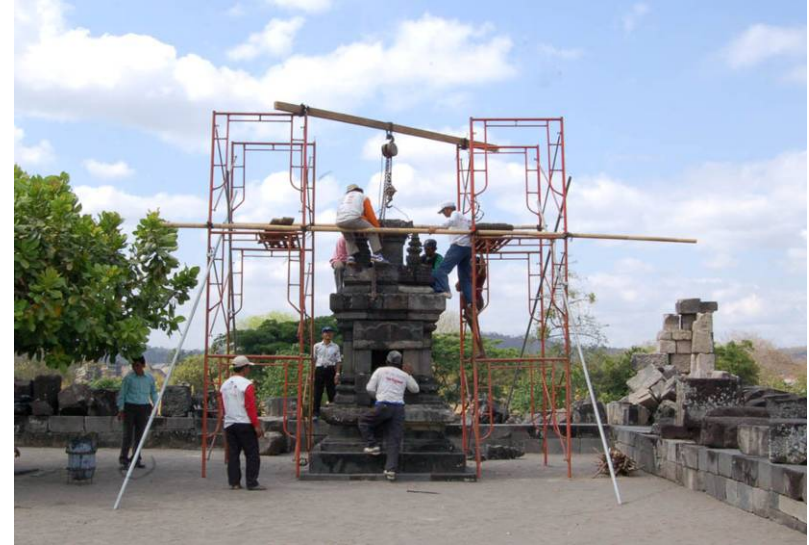
**Restoration activity after 2006 earthquake**  
*(Photo courtesy of BP3 DIY)*

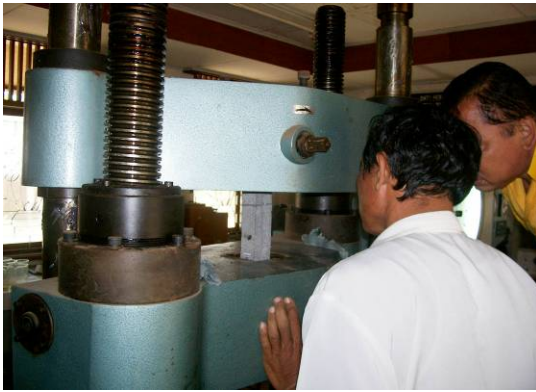
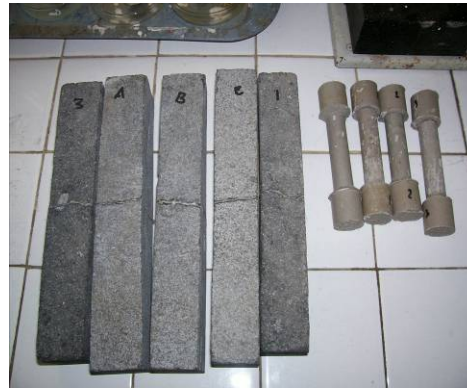
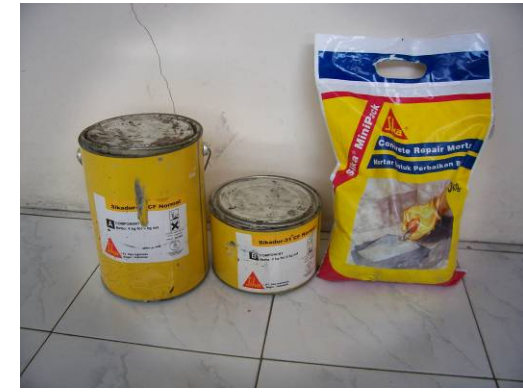
Post-earthquake activities in Prambanan Temple compound were: data collecting, dismantling the damaged components, rehabilitation and strengthening, research and test on material will be used in the restoration to choose the safest one.

The restoration of the damage temples and other building in Prambanan Temple compound were done by prioritizing physical components and strengthening the structure of the temples,

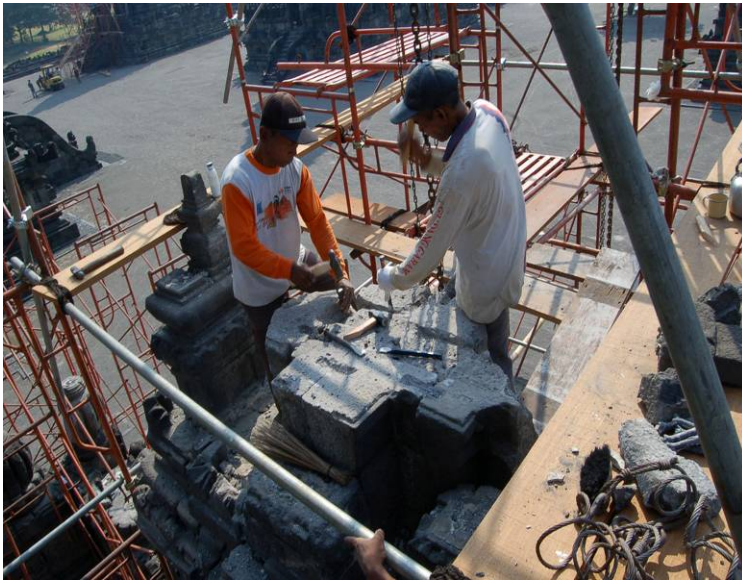
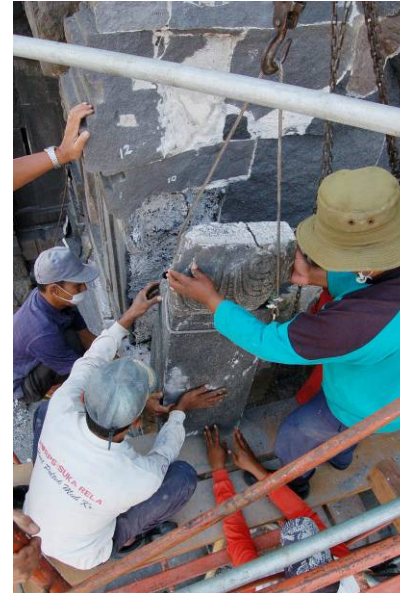
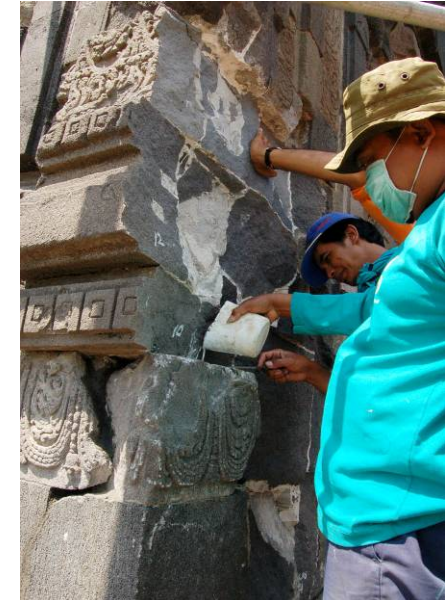
**Restoration process**  
(Photo courtesy of BP3 DIY)

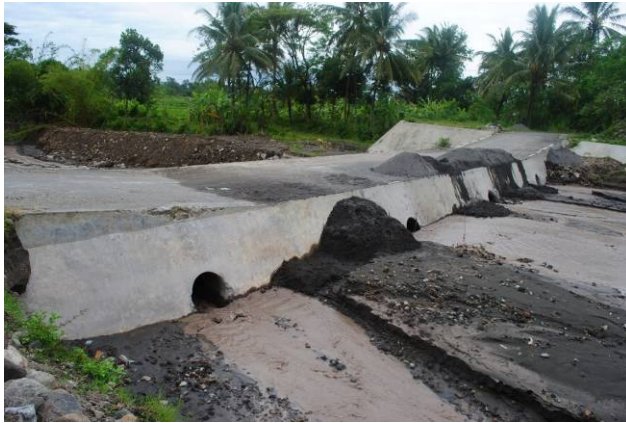
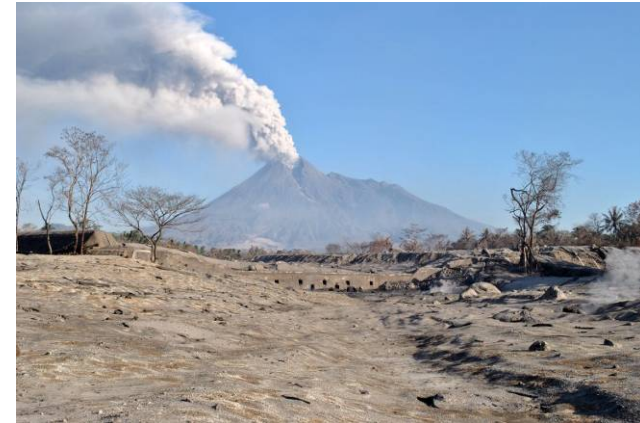
Volcanic ash rain and the eruption material can cover the temple, and give negative impact to the porous andesite stone blocks used as elements of the structure. It is because of its chemical character. Besides, there is secondary danger from the eruption of a volcano. It is cold lava flow through rivers sprung from the volcano. This might endanger Prambanan temple compound, since its site is near that type of river. Prambanan temple compound located at the foot plain of Merapi volcano. It is an active volcano with periodic eruption cycle (about once in 4 years cycle). Its primary eruption material consists of volcanic ash that can be blown by the wind to reach far away area, including the area of Prambanan temple compound. The secondary danger of a volcanic eruption is the flow of cold lava through rivers by high outpour of rain.

Damage to stone blocks as building material of the temples, due to the chemical reaction of the eruption material, and the danger of the cold lava flow. Anticipation steps in the future due to the eruption pattern of Merapi volcano. The future anticipation includes the technique of cleaning the ash rain material from the temple, and the strengthening of the river's slope used as the way for the cold lava flow.

**Impacts of Mount Merapi eruption**  
*(Photo courtesy of BP3 DIY)*
