2008 Annual Progress Report

Date: January 2009

Project Site: Chandramauleshwar Temple, Aneundi, Hampi World Heritage Site, Karnataka, INDIA

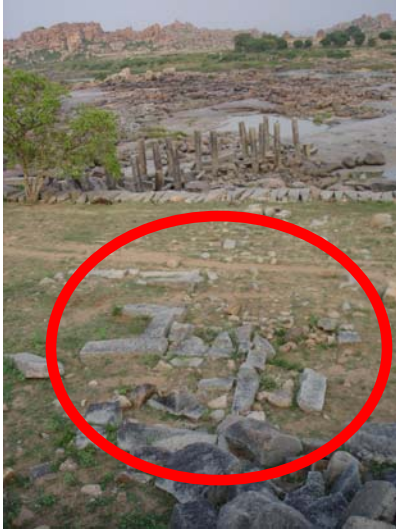
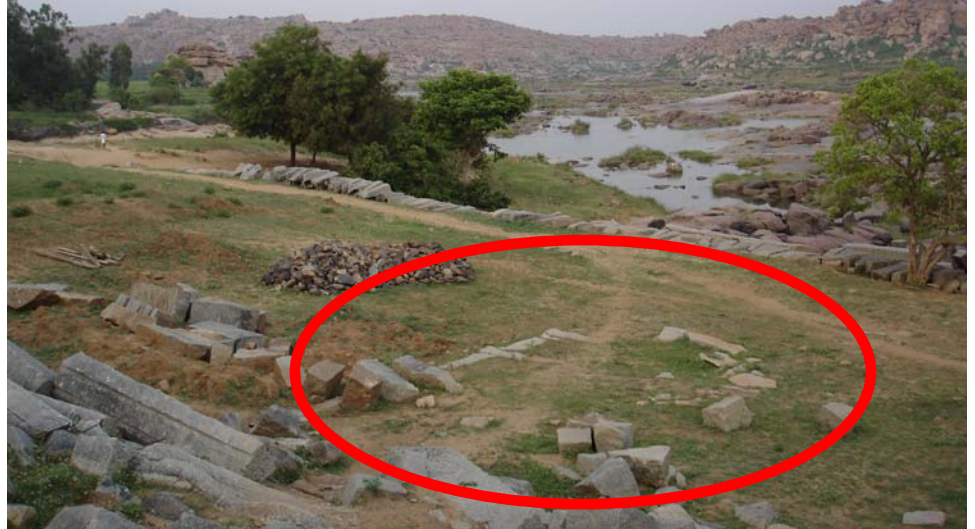
1. Investigations around the platform to the East Side

The team found another spur indicating some sort of platform on the eastern face of the temple with an interesting visual connection between the bridge and the temple. This was an interesting development, raising issues that suggest a possible linkage between the bridge and east face of temple

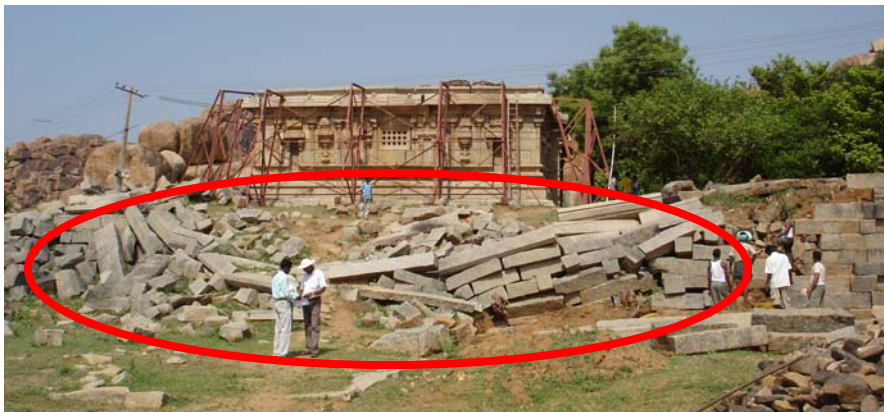
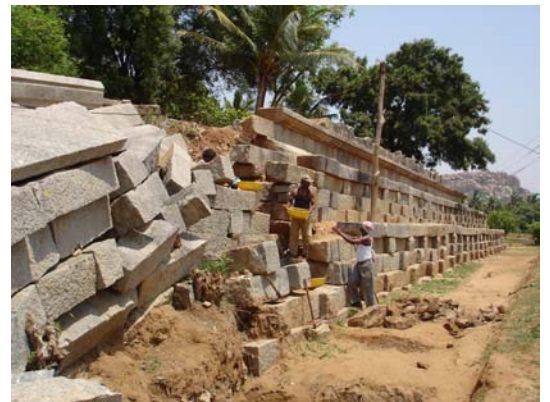
3. Establishing the height of the Upper Embankment Wall for the remaining section

- Current numbering shows E 1 stone courses missing in this section
- Is this indicative of a 'step down' in embankment wall level at this section? Or steps leading to the temple platform? Is it a turning or merely indicative of 'scavenging' for construction works?
- Documentation work
- Review of explorations around the east side showing 'base course' stone but mud and rubble above that

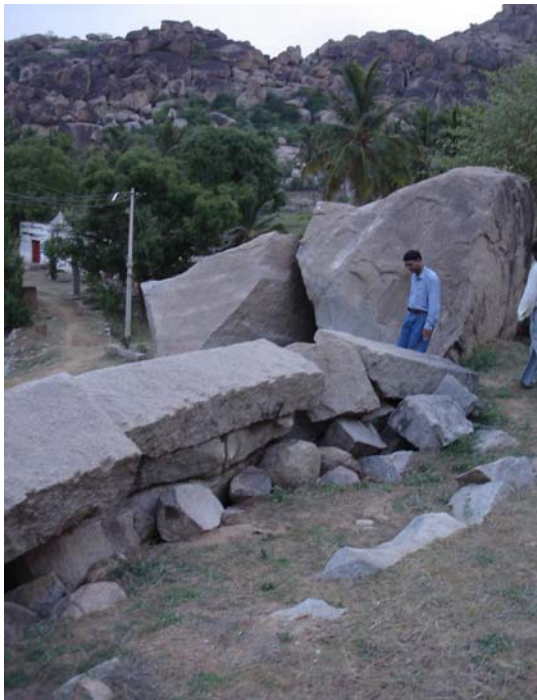
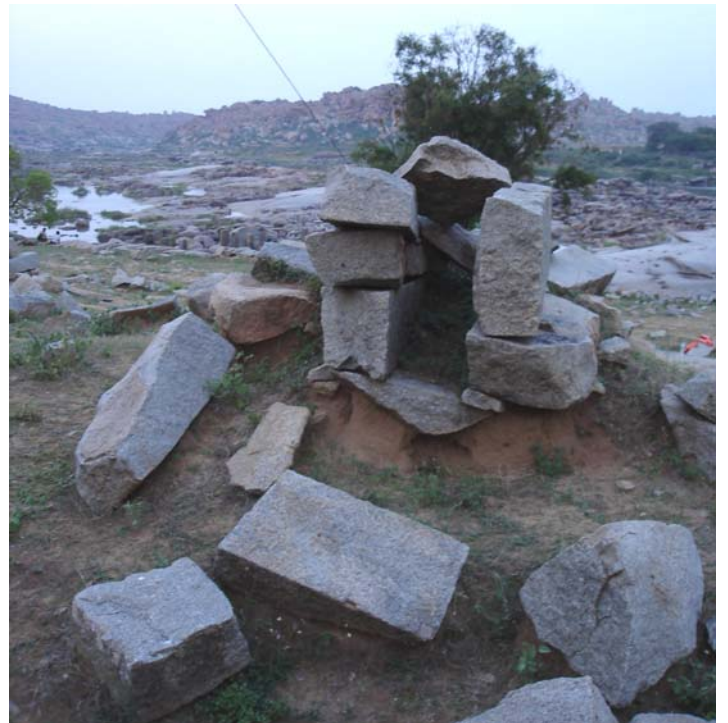
5. Establishing the height of the Upper Embankment Wall for the remaining section

- Another aspect that has continued to intrigue the team is the cistern like arrangement of stones at the southern section of the site upper platform that is indicative of a water trough or channel. The embankment walls in this section are also visible on rock face.

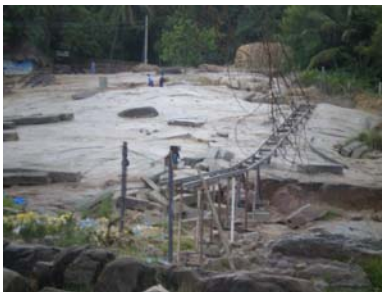
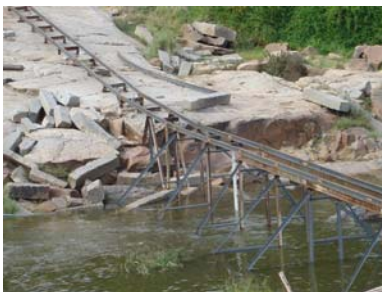
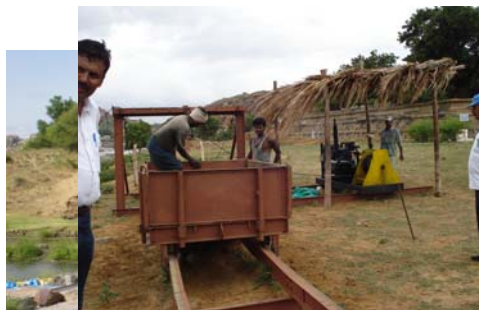
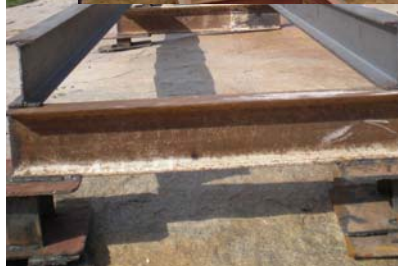
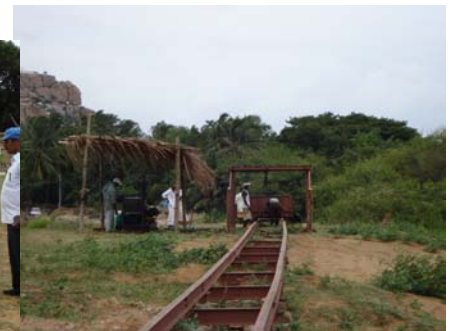
Temporary Trolley Track to Transport material

In order to transport material and tools to the site was one of the greatest challenges in the project mobilization. The site is located on an island, only accessible by crossing the river on a 'coracle' basket boat. To transport granular sand required for the soil consolidation and other tools and equipment to site, was impossible on these medieval transportation methods and the team spent a considerable amount of effort in discussing the various alternatives of creating temporary culvert bridge/ rope wires, cranes, or temporary bridging systems to transport the material over the river. Moreover, these methods had to be approved both from the point of view of minimal impact to the site, reversibility and the fact that the district administration did not want to create any temporary bridge/walkway that could be used by villagers to cross over as this would then become a convenience to the pedestrians who would oppose the dismantling of the bridge at the completion of the project.

The team explored a range of options and was acutely aware of the fact that the site was of immense archaeological importance and was clear that there should be no threat of damage to the archaeology of the medieval stone bridge through the construction of a temporary bridge. It was therefore worth the additional cost of a greater span of the proposed temporary bridge if this was going to ensure protection of the historic archaeology. Moreover, the alternative option of providing a rope pulley system to transport material would require the installation of two metal towers on either bank of nearly 7 mt height and would be unadvisable due to the visual impact on the view corridor from Vithhala and would have a visually unwelcome impact on the site. Finally, the selected method approved by the Government bodies, was one of creating a temporary rail track mechanism on steel girders, to transport the materials on a mechanized track and barrow system.

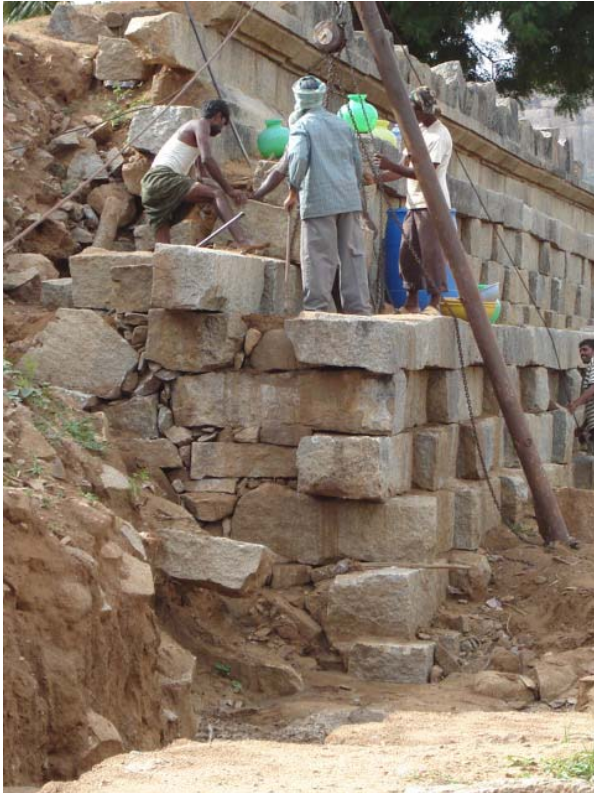
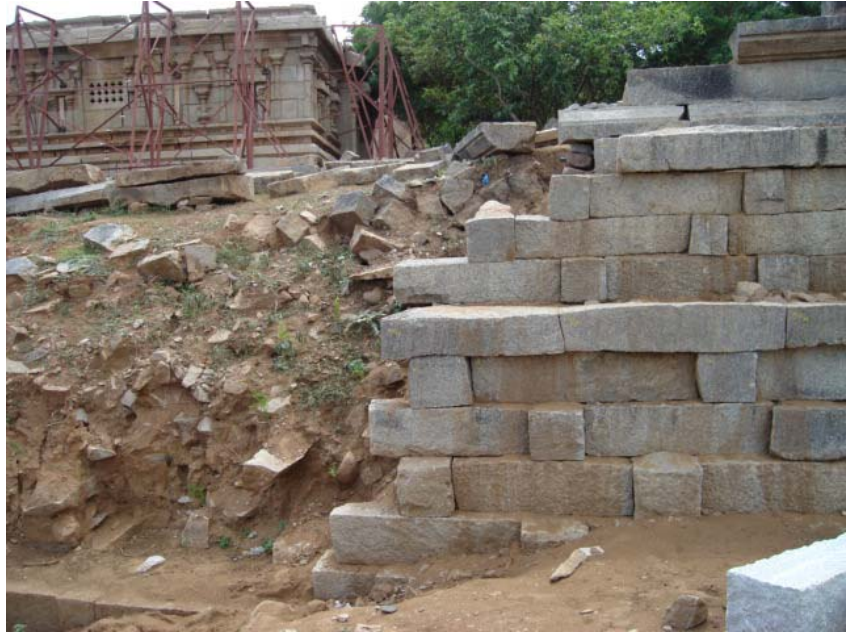
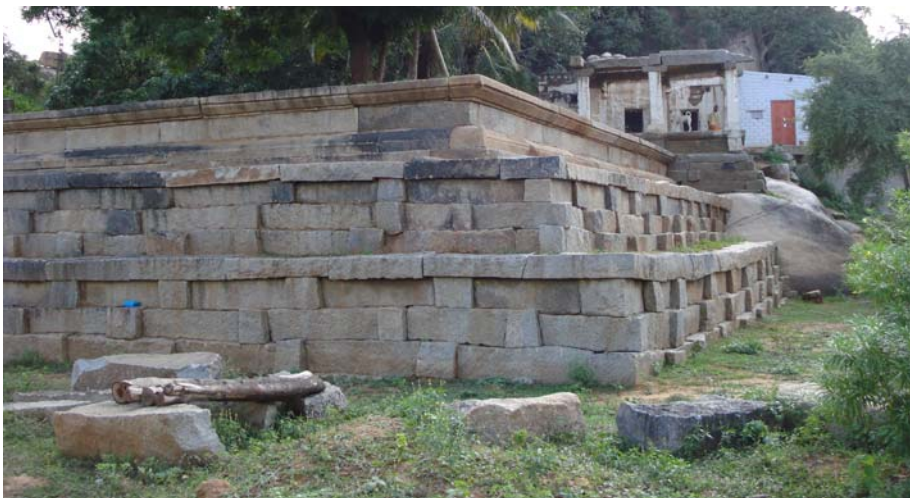
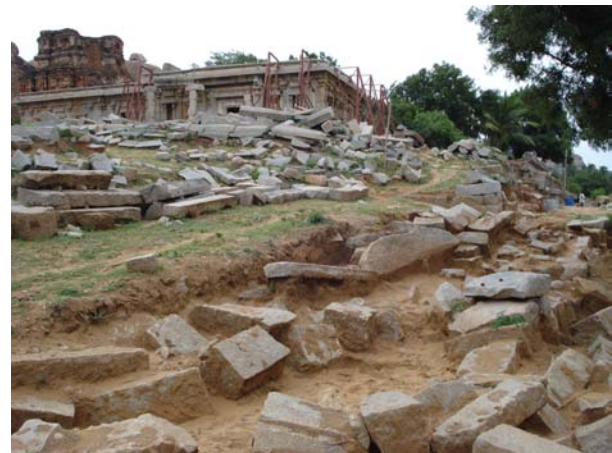
Re setting of the stone blocks along the 45 mt stretch of phase 1 of the upper embankment continued with original stones on site. New quarries for matching petrography of stone for replacement of missing sections of stone wall were also sourced from a quarry outside the Hampi World Heritage Buffer Zone.

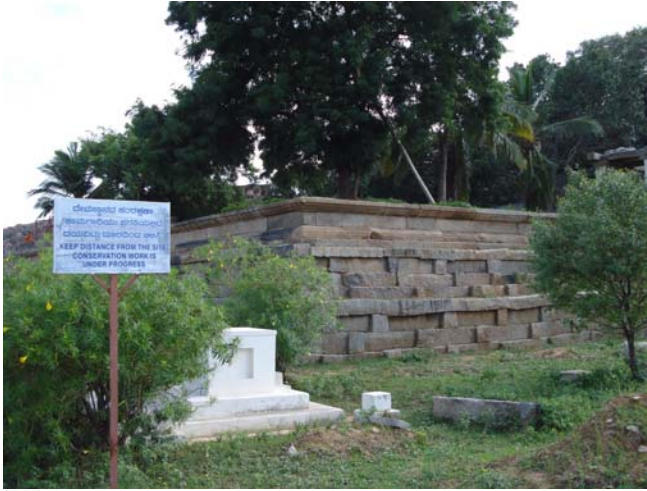
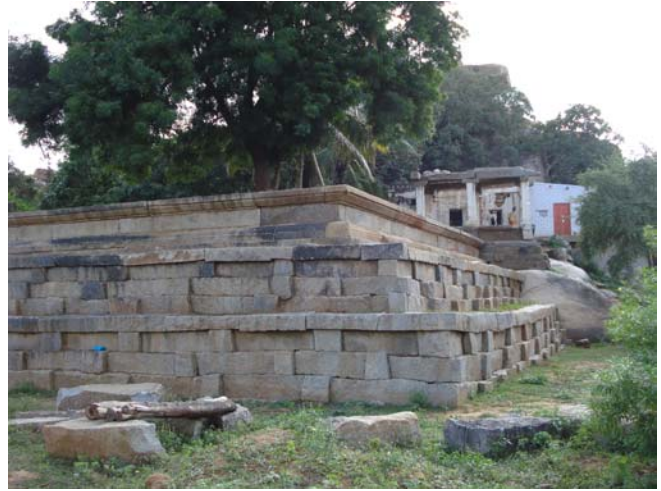
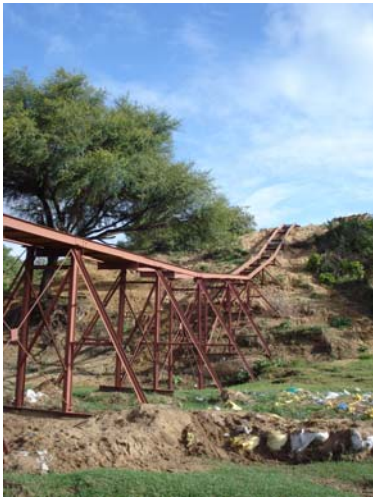
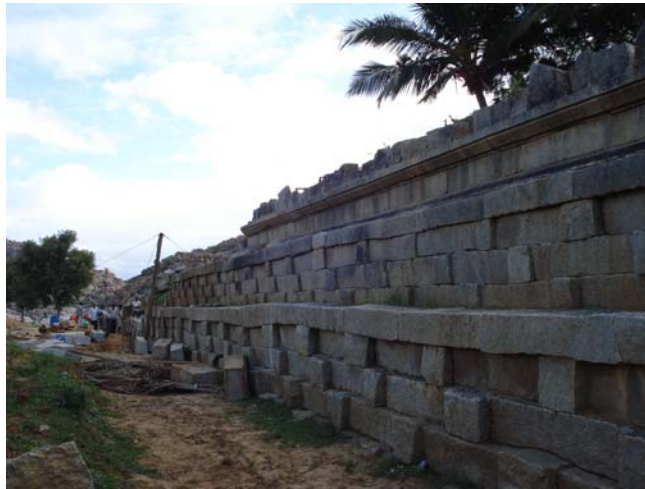
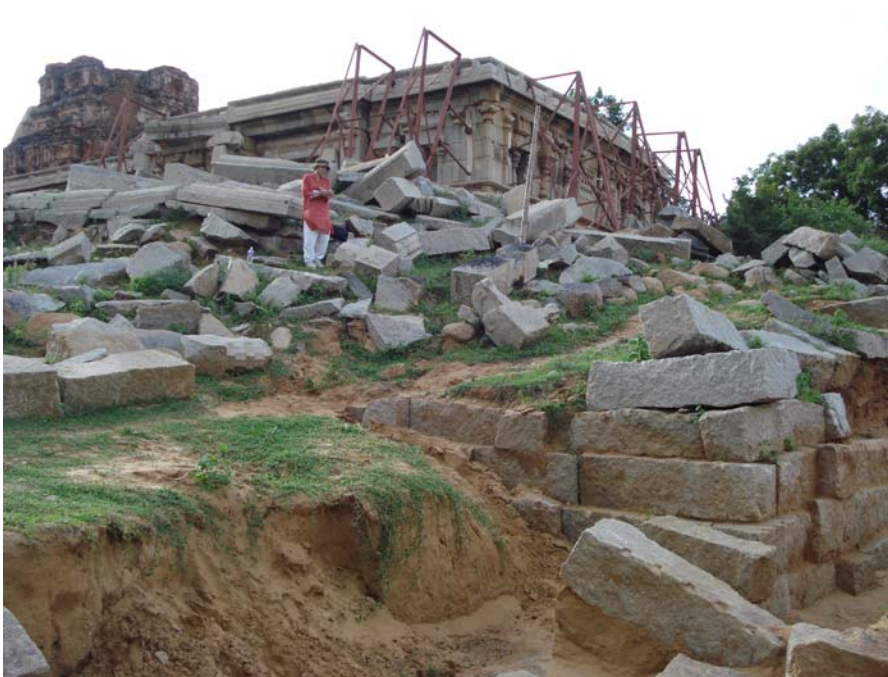
July - August 2008:

A new bend in the upper stone embankment is now visible that was earlier not seen. This leads to new light on the original construction of the upper embankment wall.

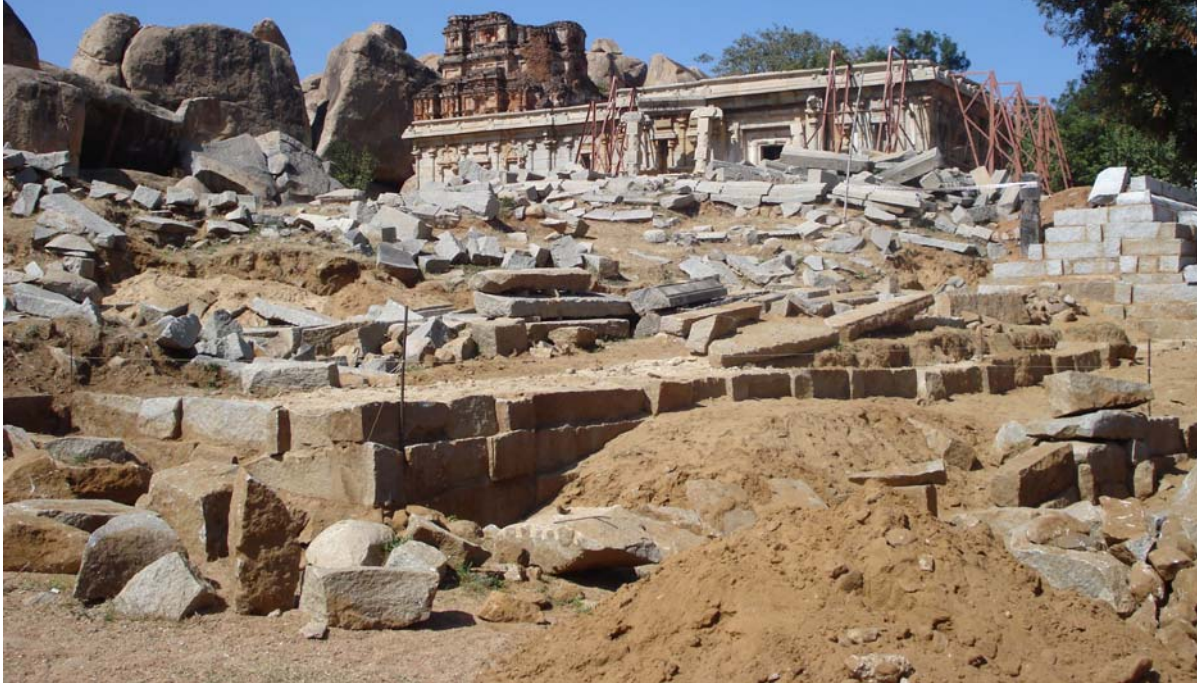
November - December 2008:

The site excavations have exposed the extant plinth level of the South East corner of the upper embankment clearly showing E1 course of the upper embankment wall extending till the SE corner. This clearly provides evidence and validates the earlier hypothesis of the site team about the turn of the upper embankment. Also exposed, is the offset at the South face of the upper embankment wall indicated steps. These are in line with the logical sequence of progression of approach to the temple along the South North axis of the temple from the lower embankment steps to the upper embankment and then with steps leading to the mandap and South entrance of the temple proper. This clearly provides evidence and validates the earlier hypothesis of the site team about the turn of the upper embankment.

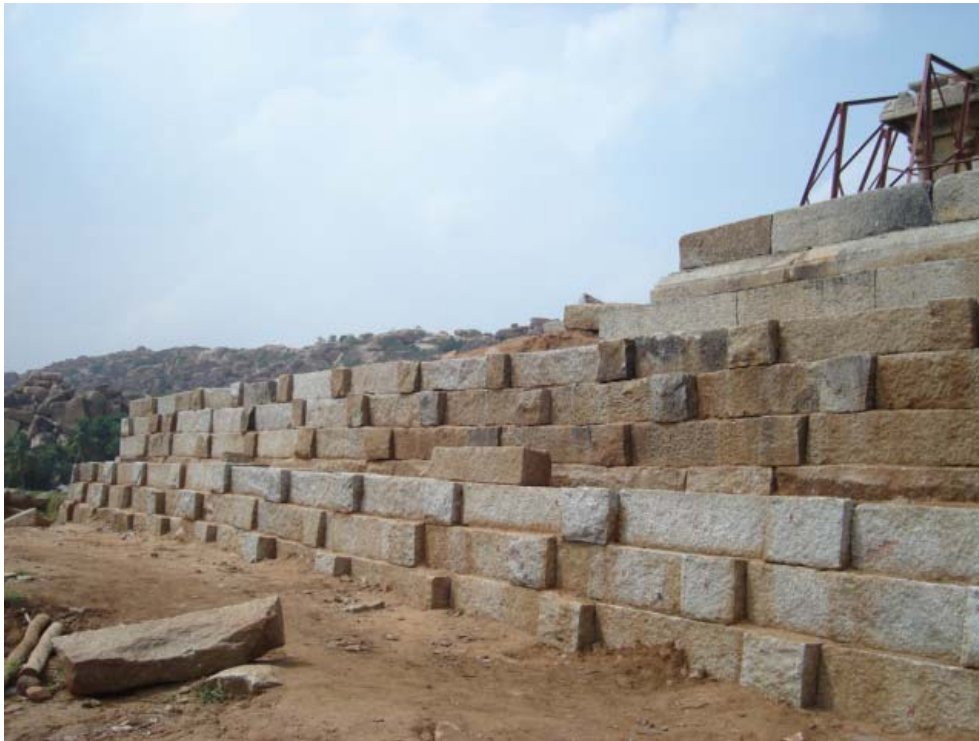
November - December 2008:

Nearly 70 metres of East face wall has been reset to E1, E2 and E3 courses as found on site. Of this, the first phase of 43 mts length relies completely on reusing and resetting old stone found on site and the next stretch of 33 mts employs partial new stone work wherever old stones were found missing or broken.

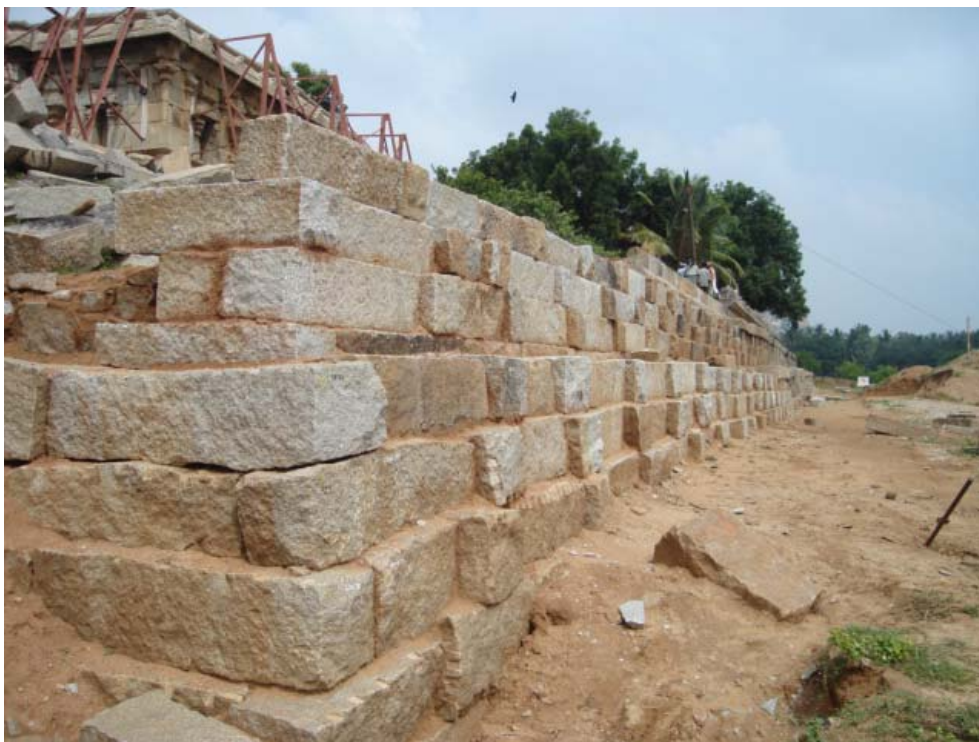
Padma stone coping course has been found extant on the South East side of the exposed plinth course and this indicates that E1 course at the platform after the E2 and E1 courses end continues the padma stone detail as a finishing cornice course. Site supervisor has photographs and documentation to support this. This clearly provides evidence and validates the earlier hypothesis of the site team about the turn of the upper embankment.
